1234 School House Road  
Yourtown, US 12345

Prepared for: Bob Smith

# Discovery Home Inspection

## SAMPLE REPORT

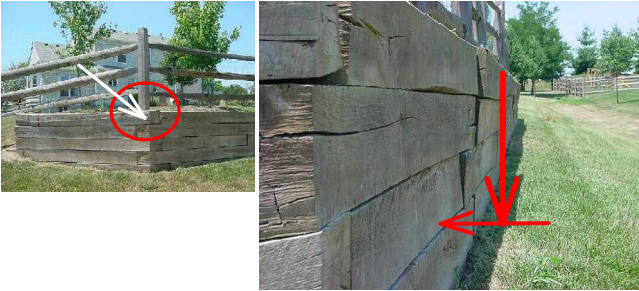
1.      Walks: Concrete
2.      Steps/Stoops: Concrete
3.      Patio: Pebble top
4.      Deck: Treated wood **The deck has been built below acceptable building standards and is not safe in its current state. Recommend further evaluation and estimate to bring deck up to an acceptable building standard.**
5.      Balcony: Concrete
6.      Porch: Concrete
7.      Vegetation: Shrubs with some weeds
8.      Retaining Walls: Railroad ties **The wall is showing signs of movement, but appears to be stable at this time. A qualified contractor is recommended to evaluate and estimate repairs to maintain the wall.**

1. Vegetation: Shrubs with some weeds
2. Retaining Walls: Railroad ties The wall is showing signs of movement, but appears to be stable at this time. A qualified contractor is recommended to evaluate and estimate repairs to maintain the wall.

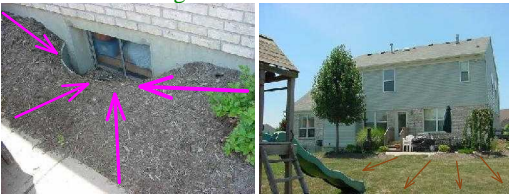
9.      Basement Stairwell: Concrete
10.      Grading: Moderate slope **The grade and landscaping materials are too high and extend above the window well at the Northeast rear of the home. Recommend that the grade be reduced or the metal window well soil retainer be replaced with a taller unit to keep the mulch and soil beds from washing into the well.**

1. Deck: Treated wood **The deck has been built below acceptable building standards and is not safe in its current state. Recommend further evaluation and estimate to bring deck up to an acceptable building standard.**
2. Grading: Moderate slope **The grade and landscaping materials are too high and extend above the window well at the Northeast rear of the home. Recommend that the grade be reduced or the metal window well soil retainer be replaced with a taller unit to keep the mulch and soil beds from washing into the well.**

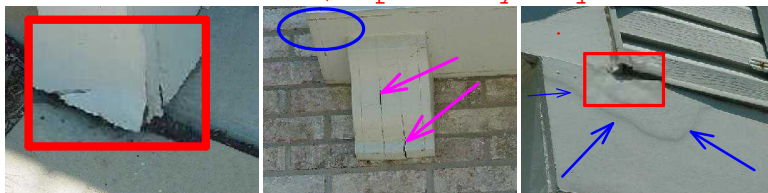
1. Water damage to trim wood at either side of garage door from moisture wicking into the finished particle board. The surface is starting to delaminate. Recommend repair/replacement of the trim boards and silicone seal wood that is in contact with concrete to prevent wicking.

2. The wood window boxes have water damage and will require repair/replacement. The wood has started to separate at the supports and at the corners of the window boxes.

3. The trim board at the southwest corner of the porch has water damage due to water penetration and will require repair/replacement of the wood. The trim board extends out creating a ledge allowing water to collect on the top edge of the board and cause the wood to rot.

1. **Water damage to trim wood at either side of garage door from moisture wicking into the finished particle board. The surface is starting to delaminate. Recommend repair/replacement of the trim boards and silicone seal wood that is in contact with concrete to prevent wicking.**

2. **The wood window boxes have water damage and will require repair/replacement. The wood has started to separate at the supports and at the corners of the window boxes.**

3. **The trim board at the southwest corner of the porch has water damage due to water penetration and will require repair/replacement of the wood. The trim board extends out creating a ledge allowing water to collect on the top edge of the board and cause the wood to rot.**

Recommend estimate/repairs by a qualified contractor.

**Recommend estimate/repairs by a qualified contractor.**

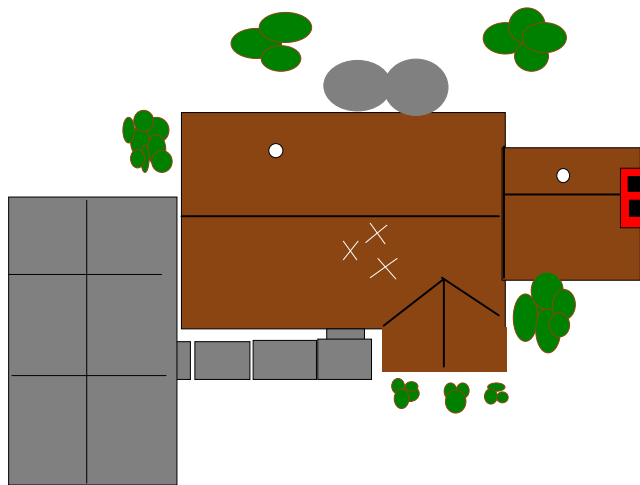
- 1. Method of Inspection: On the roof
- 2.      Unable to Inspect: 30% Height of the roof
- 3.      Material: Fiberglass shingle **Missing roof shingles from wind damage as marked "x" in diagram. Repairs are required.**
- 4. Type: Gable

5. Main Roof Surface Material: Fiberglass shingle **Missing roof shingles from wind damage as marked "x" in diagram. Repairs are required.**
6. Leader/Extension: Underground conductors **Reconnect to downspout where pulling loose.**
